DeLotech

SUMMER 1989

Parts Interchange And Service Tips

Volume: I Issue: I

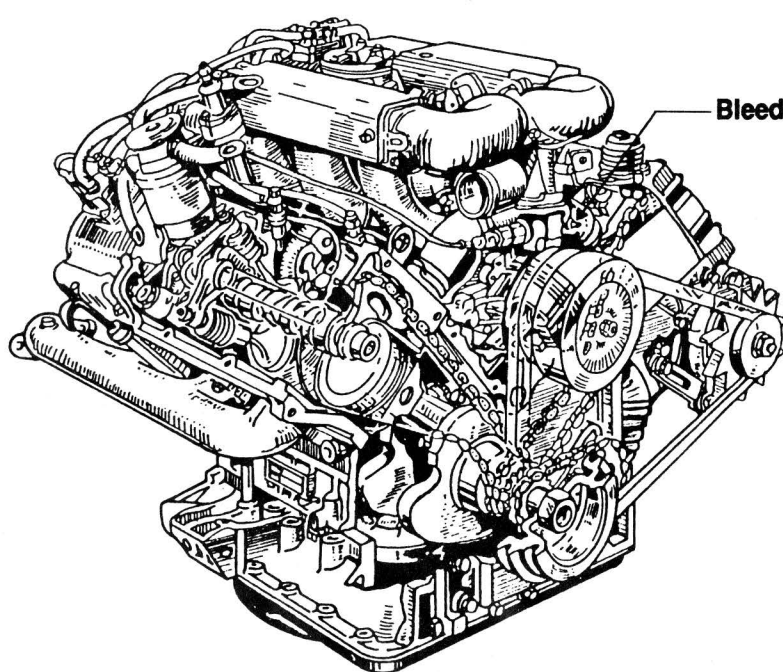
Bleeder Valve

ANYTIME OVERHEATING RESULTS IN A COOLANT LOSS OF 2 QT, BLEEDING IS INDICATED. THE BLEEDER VALVE IS BRASS, HAS A 10MM HEX BODY, AND IS LOCATED ON THE SIDE OF THE THERMOSTAT HOUSING. SEE ILLUSTRATION a. AND PROCEED AS FOLLOWS:

1. TOP UP THE COOLANT TANK WITH A 50/50 MIX OF ANTIFREEZE AND WATER. DON'T OPEN THE CAP UNTIL THE SYSTEM HAS COOLED ENOUGH TO RELIEVE PRESSURE AND UNSAFE TEMPERATURES!

2. TURN THE BLEED VALVE 1 TURN COUNTERCLOCKWISE. WAIT UP TO 10 MINUTES FOR COOLANT TO APPEAR. WHEN THE COOLANT STREAM IS 90% AIR FREE CLOSE THE VALVE. IF COOLANT DOES NOT COME OUT, APPLY GENTLE

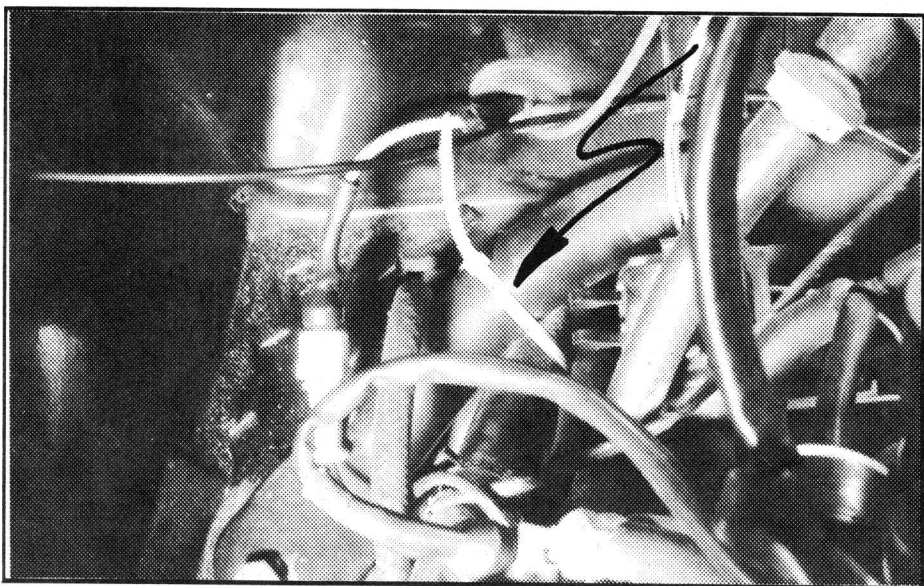
SAVE OVER \$200-WITH ONE TIE WRAP

ON MOST DELOREANS THE HIGH PRESSURE AIR CONDITIONING HOSE RUBS AGAINST THE EDGE OF THE HEX FITTING ON TOP OF THE FUEL FILTER. THIS CONDITION CAN BE CORRECTED BY SECURING THE HOSE TO THE REAR BODY CROSS BRACE. IF HAS ALREADY "POPPED", A SLICE CAN BE INSTALLED RATHER THAN REPLACING THE ENTIRE HOSE. WHENEVER YOU HAVE AN AIR CONDITIONING REPAIR THAT REQUIRES OPEN-
